INVESTIGATION OF 3"/70 CARTRIDGES FROM AMMUNITION LOT PV-4-C-57

Date: 23 February 1961

NWL REPORT NO. 1741

The premature ignition of a 3"/70 cartridge aboard the USS WILLIS A. LEE (DL-4) resulted in a serious casualty. Various tests with cartridges and cartridge components from the same ammunition lot, PV-4-C-57, failed to reproduce a similar preignition. It was concluded that: the cartridges from ammunition lot PV-4-C-57 appear to be serviceable; the premature ignition, upon ramming, of a 3"/76 cartridge probably would not be caused by solid propellant grain slivers or black powder grains becoming lodged between the cartridge case and projectile; the wad for a full case assembly is not adequate for all 3"/70 full service charge assemblies; the proposed bullet pull-out load requirements are unrealistic for the Mk 34 Mod 3 projectile; and that electromagnetic radiation was not the cause of the casualty. It was recommended that two Pc. No. 26 (wads) be used in a full case assembly, a wad of 4-inch diameter be adopted and used together with two distance pieces whenever Pc. No. 26 is inadequate; i. e., for a PPD range from 2".2 to 4".5 inclusive, and the proposed bullet pull-out loa

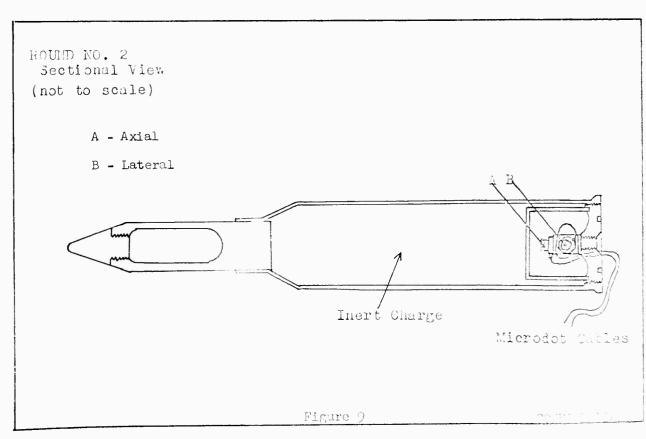
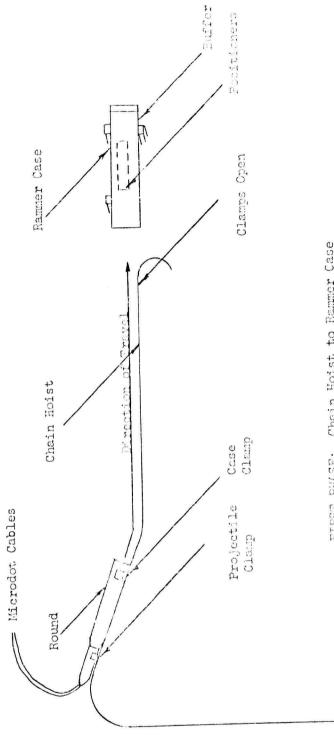
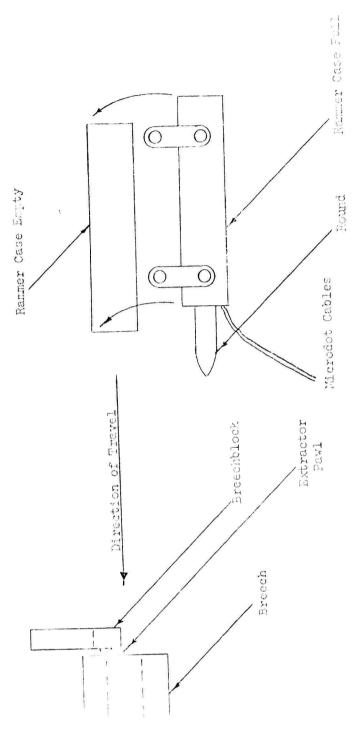
Figure 11

Side View of Mount (Not to Scale)

FIRST FILESE: Chain Hoist to Rammer Case

Top View of Mount (Not to Scale)

SECOND FIMSE: Rammer Case to Gun Chamber
